## An Experimental Investigation of the Failure of a Stepped Composite Plate

Thesis by  
Steven C. Gortsema

In Partial Fulfillment of the Requirements for the Degree of  
Aeronautical Engineer

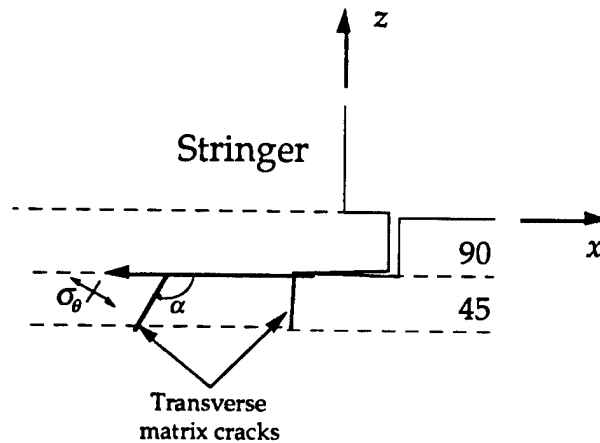
Another part of the delamination mechanism that should be explained is its relation to transverse matrix cracking in the  $45^\circ$  ply, as observed on the  $-x$  portion of the negative edge (Figure 21).

Figure 21. Cracking in the  $45^\circ$  ply on the  $-x$  side of the step.

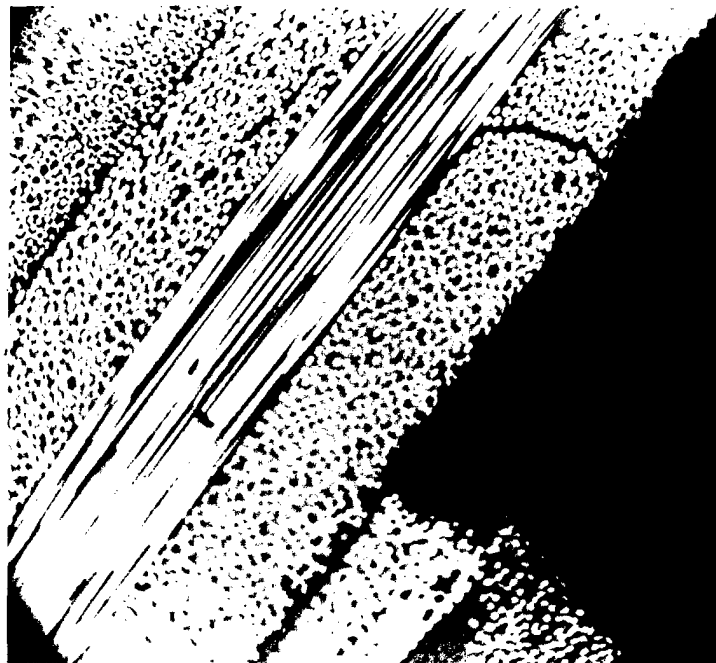
At approximately the same load,  $0^\circ$  fiber fractures are often observed ahead of the  $45^\circ$  ply crack nearest the corner (shown by "2B" in Figure 27). In some cases this crack even turns and begins to propagate stably in the  $-x$  direction along the  $45/0$  interface (Figure 28b).

Figure 28b. Stable propagation along the 45/0 interface.
